Manhole Inspection Summary

Manhole # S15QQ1005MH

Location Address: **4914 GREENSPRING AVE**

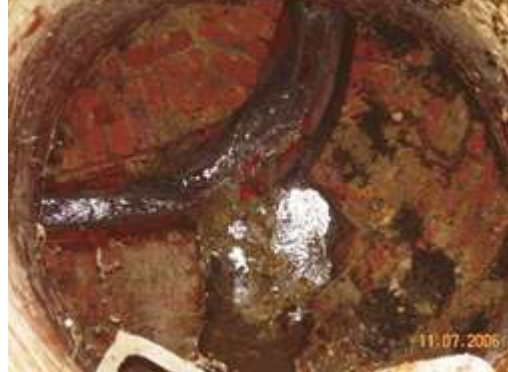
Top View

Evidence of surcharge - Bench debris.
Channel debris.

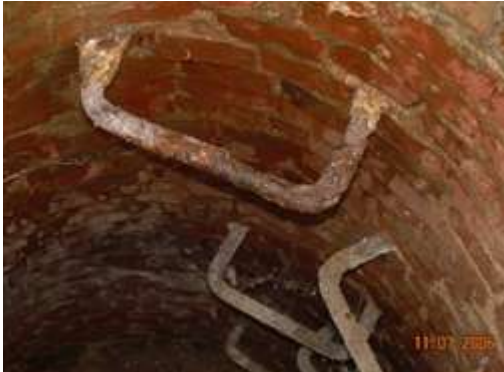
Defect

Adjustment deterioration and infiltration.
Barrel infiltration. Corroded steps.

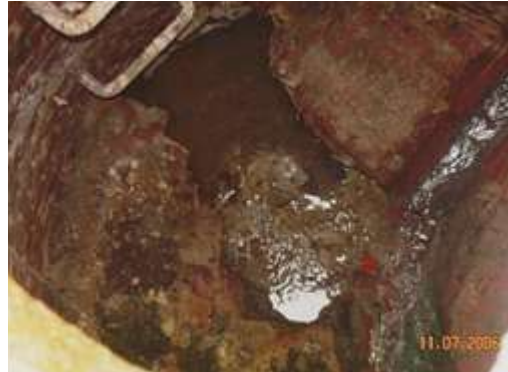
Defect

Bench cracks and deterioration.

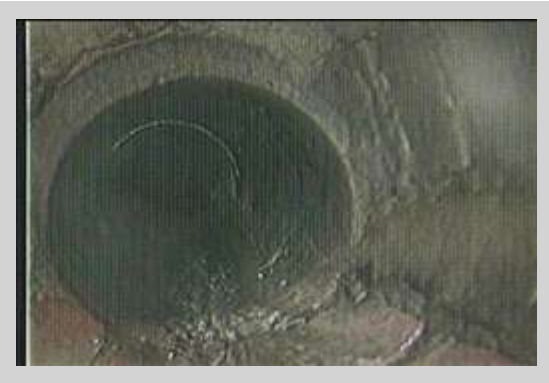
8 in. Circular Gravity Sewer Pipe Out @ 12 O'Clock

Infiltration: **Evidence** Pipe Seal Cond: **Cracked**

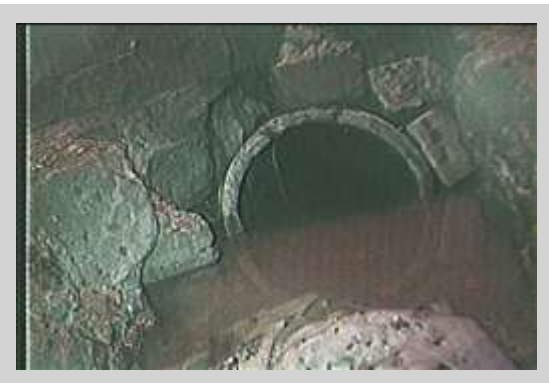
8 in. Circular Gravity Sewer Pipe In @ 6 O'Clock

Barrel deterioration, loose brick and infiltration. Bench and Channel deterioration.

Infiltration: **Evidence** Pipe Seal Cond: **Broken**

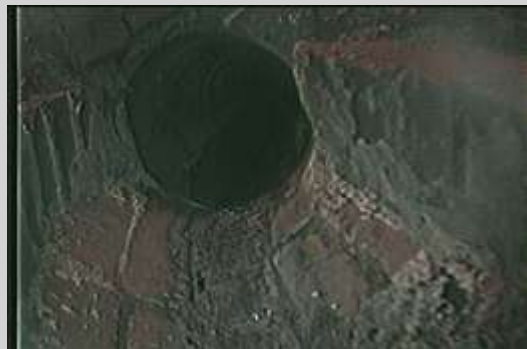
Pipe In @ 9 O'Clock

Infiltration: **Evidence**
